## Preservation Environment Evaluation

eClimateNotebook® - Image Permanence Institute - Rochester Institute of Technology - © 2017 Overview Report - Created: 2017-10-18

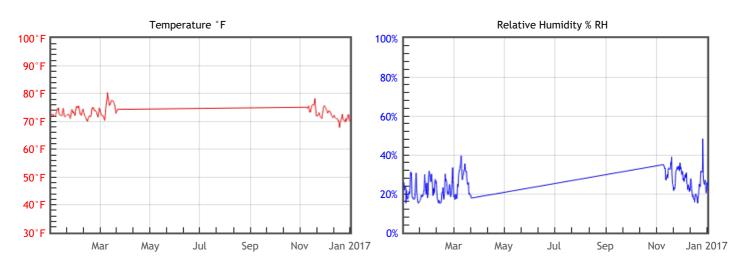
#### Graphs

Type of Decay	Risks & Metrics	Evaluation & General Comments
Natural Aging Chemical decay of organic materials	OK TWPI = 61	Generally OK, but fast decaying organic materials such as acidic paper, color photographs and cellulosic plastics will be at elevated risk due to the cumulative effects of temperature and humidity
Mechanical Damage Physical damage to hygroscopic materials	<b>RISK</b> % DC = 0.88 % EMC min = 4.6 % EMC max = 7.8	Heightened risk of physical damage to any hygroscopic material, such as paintings, rare books, furniture, paper, leather, film, or color photos, due to extremely low or high levels of humidity, and / or excessive humidity fluctuation.
Mold Risk Mold growth in area or on collection objects	GOOD MRF = 0	Minimal risk of mold growth.
Metal Corrosion Corrosion of metal components or objects	OK % EMC max = 7.8	Generally OK, but archeological or salt-encrusted metals may corrode due to extended periods of moderately high levels of humidity.

Temperature		Relative Humidity		Dew Point	
T°F Mean	73.3	%RH Mean	24	DP°F Mean	33.2
T°F Median	72.9	%RH Median	24	DP°F Median	34
T°F Stdev	2	%RH Stdev	7	DP°F Stdev	8.1
T°F Min	67.8	%RH Min	15	DP°F Min	19.4
T°F Max	80.4	%RH Max	48	DP°F Max	55.9

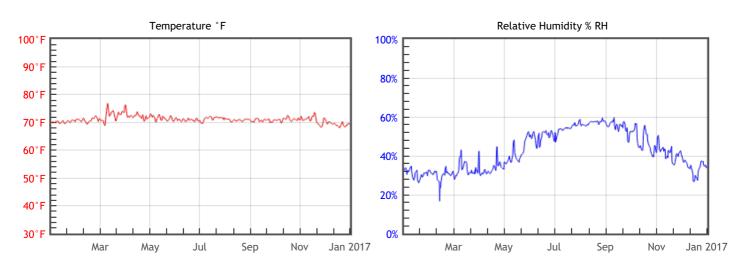
### Graphs

Type of Decay	Risks & Metrics	Evaluation & General Comments
Natural Aging Chemical decay of organic materials	ок ТWPI = 46	Generally OK, but fast decaying organic materials such as acidic paper, color photographs and cellulosic plastics will be at elevated risk due to the cumulative effects of temperature and humidity
Mechanical Damage Physical damage to hygroscopic materials	OK % DC = 1.2 % EMC min = 6.1 % EMC max = 10.4	Generally OK, but sensitive or fast responding hygroscopic materials such as paintings, rare books, vellum manuscripts or musical instruments will be at elevated risk of physical damage due to fluctuations of humidity.
Mold Risk Mold growth in area or on collection objects	GOOD MRF = 0	Minimal risk of mold growth.
Metal Corrosion Corrosion of metal components or objects	OK % EMC max = 10.4	Generally OK, but archeological or salt-encrusted metals may corrode due to extended periods of moderately high levels of humidity.

Temperature		Relative H	Relative Humidity		Dew Point	
T°F Mean	71	%RH Mean	39	DP°F Mean	43.9	
T°F Median	70.9	%RH Median	35	DP°F Median	42.1	
T°F Stdev	1.5	%RH Stdev	10	DP°F Stdev	6.6	
T°F Min	66.4	%RH Min	17	DP°F Min	21.7	
T°F Max	77.8	%RH Max	62	DP°F Max	57.8

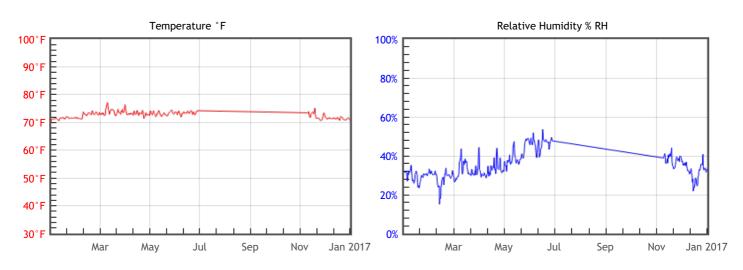
### Graphs

Type of Decay	Risks & Metrics	Evaluation & General Comments
Natural Aging Chemical decay of organic materials	ок Тพрі = 49	Generally OK, but fast decaying organic materials such as acidic paper, color photographs and cellulosic plastics will be at elevated risk due to the cumulative effects of temperature and humidity
Mechanical Damage Physical damage to hygroscopic materials	OK % DC = 0.77 % EMC min = 5.9 % EMC max = 8.7	Generally OK, but sensitive or fast responding hygroscopic materials such as paintings, rare books, vellum manuscripts or musical instruments will be at elevated risk of physical damage due to fluctuations of humidity.
Mold Risk Mold growth in area or on collection objects	GOOD MRF = 0	Minimal risk of mold growth.
Metal Corrosion Corrosion of metal components or objects	OK % EMC max = 8.7	Generally OK, but archeological or salt-encrusted metals may corrode due to extended periods of moderately high levels of humidity.

Temperature		Relative Humidity		Dew Point	
T°F Mean	72.4	%RH Mean	34	DP°F Mean	42.2
T°F Median	72.8	%RH Median	33	DP°F Median	41
T°F Stdev	1.5	%RH Stdev	6	DP°F Stdev	5.3
T°F Min	69.2	%RH Min	15	DP°F Min	21.9
T°F Max	77.4	%RH Max	54	DP°F Max	56.4
